**Land East of Kidderminster Road,
Hampton Lovett, Worcestershire**

Road Safety Audit Stage 1

TMS reference no: 16950
Date: 13th April 2022

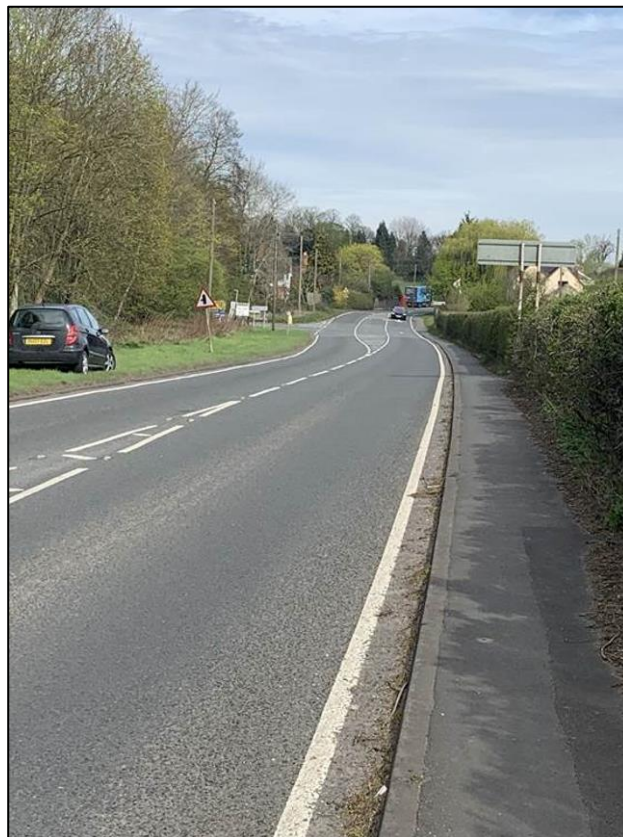
Location: Three proposed new central islands on Kidderminster Road

Summary: Risk of loss of control collisions if vehicles strike the islands at night.

As Kidderminster Road is unlit at the location, during the hours of darkness, vehicles approaching the ghost islands may be unaware of the central refuges, especially if the Keep Left bollards become dirty or are damaged. This could increase the likelihood of a vehicle hitting the central refuges and losing control, resulting in injury to vehicle occupants.

Road unlit where islands are proposed

The islands should be illuminated with high mounted beacon poles and Keep Left signs, in addition to the Keep Left bollards on the nosings.

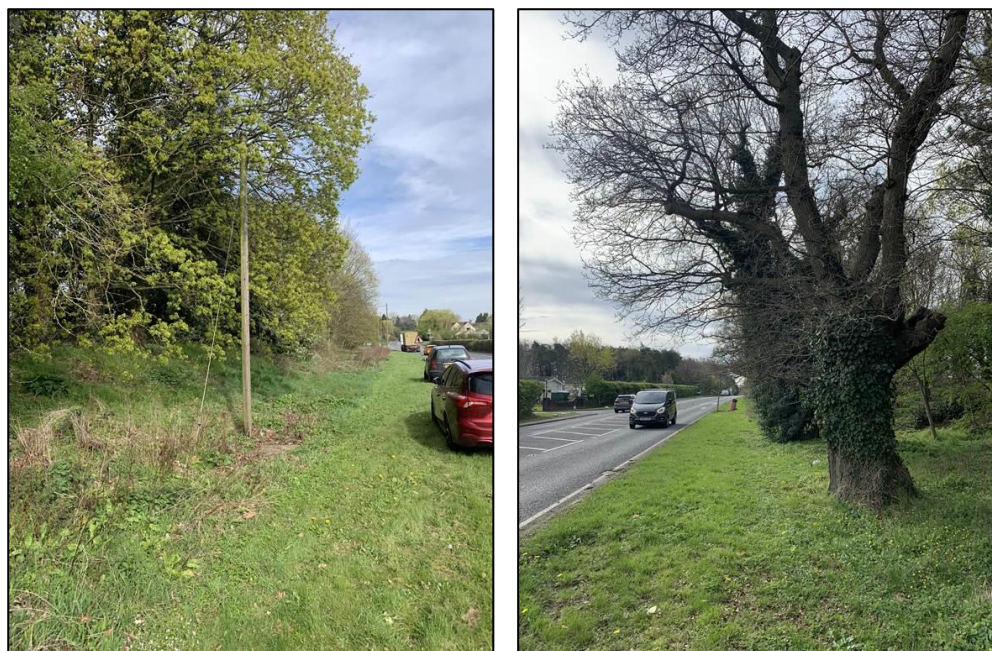
Location: Western verge in vicinity of road widening

Summary: Risk of injuries if vehicles leave carriageway and collide with roadside objects.

In the verge adjacent to the proposed new carriageway widening, there is a telegraph pole and mature trees. These may pose serious deceleration injuries to vehicle passengers should a vehicle lose control and leave the carriageway at this point. Furthermore there are several trees whose canopies will be hanging over the carriageway which could result in vehicle strikes from high sided vehicles.

Mature trees and telegraph pole adjacent to proposed carriageway widening

A Road Restraints Risk Assessment Process (RRRAP) should be carried out to ascertain whether further safety features are required to prevent serious injuries (especially as recorded vehicles speeds in the Transport Assessment are in the region of 50mph). In addition, the trees should be pruned so their canopies do not overhang the carriageway.

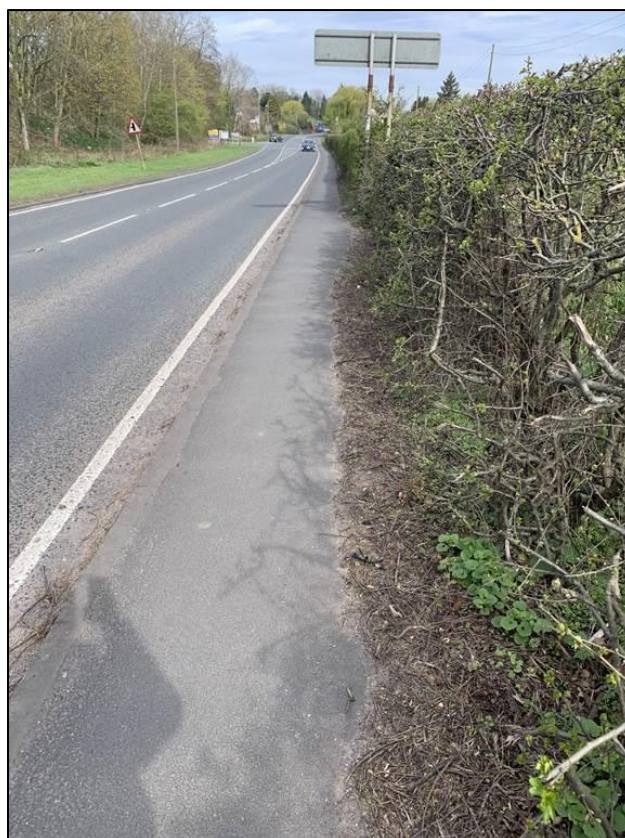
Location: Footway on eastern side of Kidderminster Road

Summary: Increased risk of pedestrians being struck by vehicles, particularly mobility impaired pedestrians.

On the eastern side of Kidderminster Road, vegetation has overgrown the footway, limiting the available width for pedestrians travelling to and from the development. Pedestrians, particularly those with mobility impairments, will find it difficult to negotiate the footways safely and as this section of the A442 carries numerous HGVs, they could be affected by the wind turbulence created by large vehicles and could be struck by their wing mirrors.

Footway narrowed by overgrown vegetation

The vegetation should be cut back and the footway maintained with a 2m width.

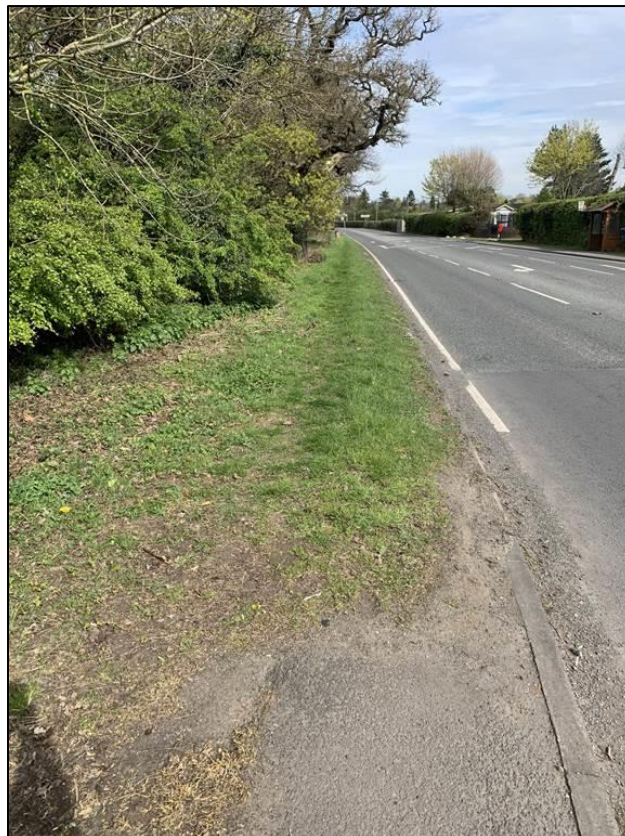
General: Footway / Cycleway links with new development

Summary: Increased risk of collisions involving pedestrians or cyclists

There are no planned improvements to either the footways or cycleway links with Hampton Lovett Industrial Estate, NCN Route 45 or crossing facilities for the Bus Stops on Kidderminster Road, adjacent to the proposed development. There is evidence that the verge on the western side of Kidderminster Road is being used to access the bus stop. With an increase in pedestrian and cycle movements from the development, there could be an increased risk of collisions involving pedestrians and cyclists if facilities are not improved.

Worn verge where pedestrians are accessing the bus stop

Improvements to the footways and cycle access to the development should be provided, linking to local facilities. Furthermore, the southern island should be upgraded to a pedestrian crossing refuge island to improve access to the bus-stop on the western side of Kidderminster Road.
